Dana telefonike

506/1BI

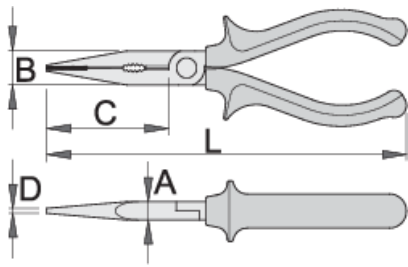
Barcode	L	B	D	A	C	Weight
607874	140	15	2	8	39	115
607875	160	16	2.5	9	49	137

Barcode	L	max 1600 N/mm ² Ø↑	max 650 N/mm ² Ø↑
607874	140	1,6	2,0
607875	160	1,6	2,0
