# Dana telefonike

506/1BI

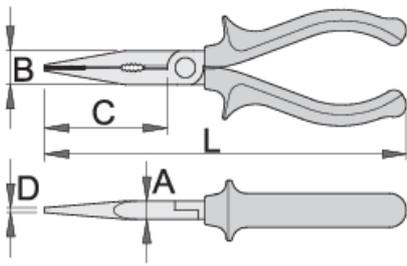
L	B	D	A	C	
607875	160	16	2.5	9	49	137

Kapaciteti i prerjes (10N = 1 kg)

L	max 1560 N/mm <sup>2</sup> Ø↑	max 750 N/mm <sup>2</sup> Ø↑
607875	160	1,6	2,0
